Structural response of drystone Iron Age brochs

Thew, I, Sutherland, A & Theodossopoulos, D 2012, 'Structural response of drystone Iron Age brochs', *Structures and Buildings*, vol. 166, no. 6, pp. 316-324. <https://doi.org/10.1680/stbu.11.00056>

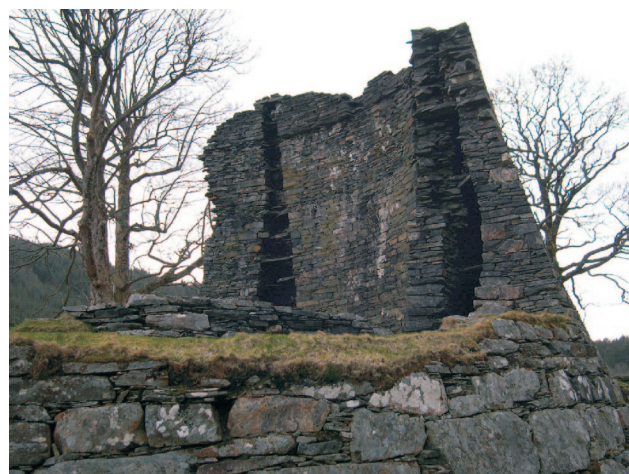
Figure 1. Dun Telve, Glenelg

A key design feature (Figures 1 and 2) is the double-leaf wall that tapers to form a truncated conoid, with very few openings. Local flagstone or volcanic rock was used, producing structures of considerable height (up to 15 m), so presumably their construction required a shared awareness of the stability problems when building to such a scale.

The double-leaf construction method is a very recognisable characteristic of the brochs. Either starting at the base (ground-galleries) or from a stone platform in the solid-based examples, two separate walls often run to the top of the building. Intra-mural stairs and galleries made from stone lintels span between the two walls. It has been suggested that these stone lintels acted as props between the two walls, keeping them apart, rather than the bracing effect of modern ties (as they do not bond deeply in the wall). Figure 1 shows this feature of the construction.

A distinguishing feature of all the brochs that still stand to a significant height is the profile. There is a distinct camber that gradually increases before decreasing and straightening (Figures 1 and 2).

Dun Telve is one of a pair (together with Dun Trodden) of solid-based brochs in Glenelg, in West Scotland, surviving at a height of 10.22 m for around a quarter of its circumference and with ED = 18.2 m and PWB = 47% (Figure 1). Often cited by archaeologists as the most representative of all brochs (Curle, 1916), it is very well constructed and preserved; the central court is quite perfect, with a standard deviation of only 2 cm from a true circle (MacKie, 2002). The fine quality of stonework is attributable to the use of long rectangular blocks producing a tight drystone bond.

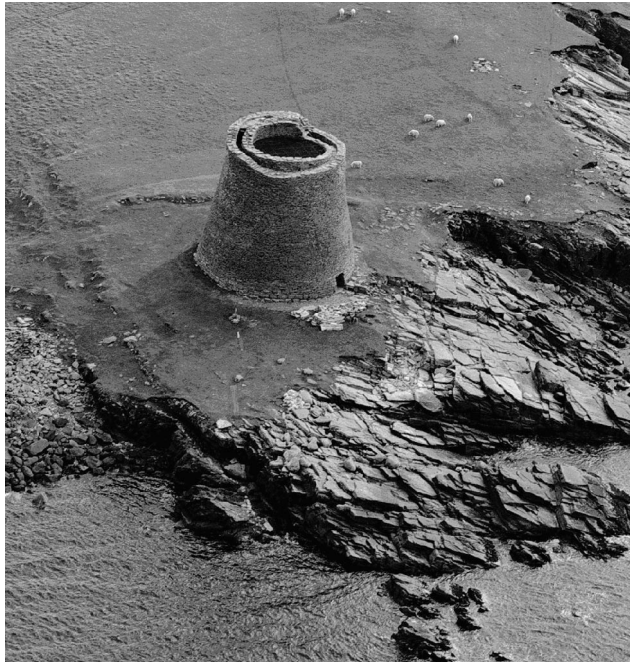
Figure 2. Mousa, Shetland (© RCAHMS (John Dewar Collection).
Licensor www.rcahms.gov.uk. Available from CANMORE (2011))

Of the brochs still standing to a good height, indications show they would have stood to at least 10 m, with a number, among which Mousa (Figure 2), exceeding that (Mousa stands at 13.5 m). While the exact number of brochs that once stood to such a significant height is uncertain (MacKie, 2002), the massive scale of the basal remains at broch sites across Scotland suggest that hundreds were at least capable of supporting walls to something close to 10 m.

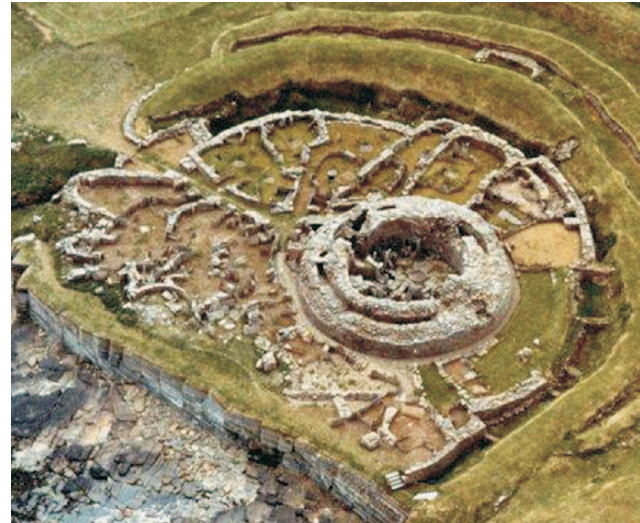
Figure 3. Gurness, Orkney (© Crown Copyright: RCAHMS.
Licensor www.rcahms.gov.uk. Available from CANMORE (2011))

Brochs broadly fall into two categories, the ground-galleried broch, where the galleries in the wall start at ground level (represented by Gurness, Figure 3), and the solid-based broch, where the continuous galleries start only after the first-floor level (Dun Telve, Figure 1). A third transitional category is very widely defined and was ignored for the purposes of this study.

While the broch of Gurness (Figure 3) is not as complete, with ED = 19.2 m and PWB = 46.0% it is a particularly large and impressive example of a ground-galleried broch. There is little evidence as to how high it originally stood; however, the scale of the base and quality of stonework (large oblong blocks) suggest it could support considerable fabric and it is not unreasonable to suggest a height between 8–10 m (MacKie, 2002). Internal partitions in flagstones have raised interesting questions about the use of the building, but since they have no load-bearing function they will not be considered.

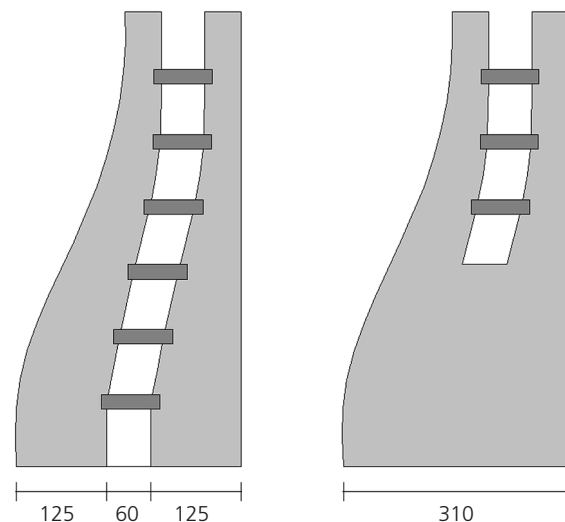
Figure 4. Cross-section of the ground-galleried 'Gurness' (left) and solid-based 'Dun Telve' (right) models

The 1:15 models were constructed according to the dimensions set out in Table 1. The key difference between the two models is the basal style: the ground-galleried 'Gurness' model has its walls beginning separately right from the base, with 'tie stones' placed across the gallery at every 90 mm level; the solid-based 'Dun Telve' model instead has a solid walled construction for the first 3 levels or 270 mm. The dimensions of the entrance passage were defined as 100 mm in width and 120 mm in height. The different construction types of the two models are illustrated in Figure 4.

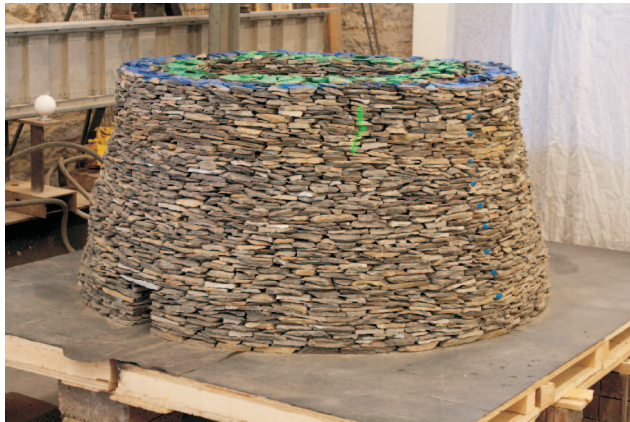
Figure 5. Completed 'Gurness' model

Using the above techniques most of the key features outlined in the earlier sections were incorporated into the models. Figure 5

shows the quality of construction which represents successfully the prototype as ascertained by the industrial partners.

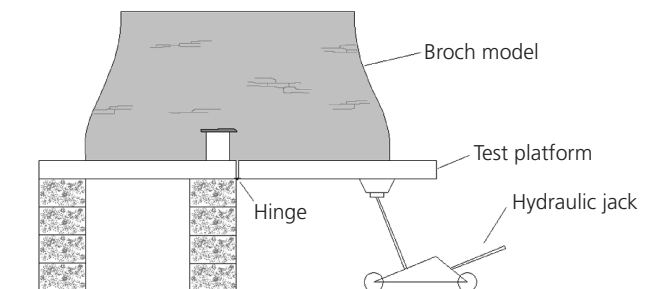
Figure 6. Test set-up (south elevation)

The broch models were built on a plywood platform of medium roughness with a hinge running down the centre (Figure 6). Three hydraulic jacks were used to support the cantilevered half of the platform and subsequently apply and control the action of settlement to the model. As the cantilevered half of the platform rotated down, a gap opened between the two halves of the

platform. To prevent stones falling into this gap a plastic membrane was put over this gap.

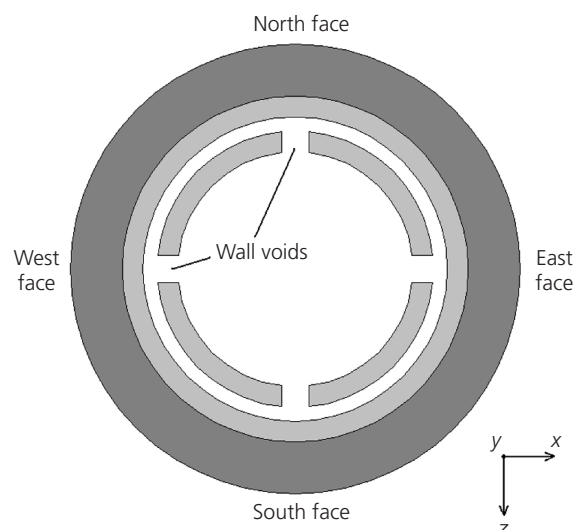
Figure 7. Orientation of model

The orientation of the model is illustrated in Figure 7, with the settlement applied on the east face and the hinge running on the north-south axis.

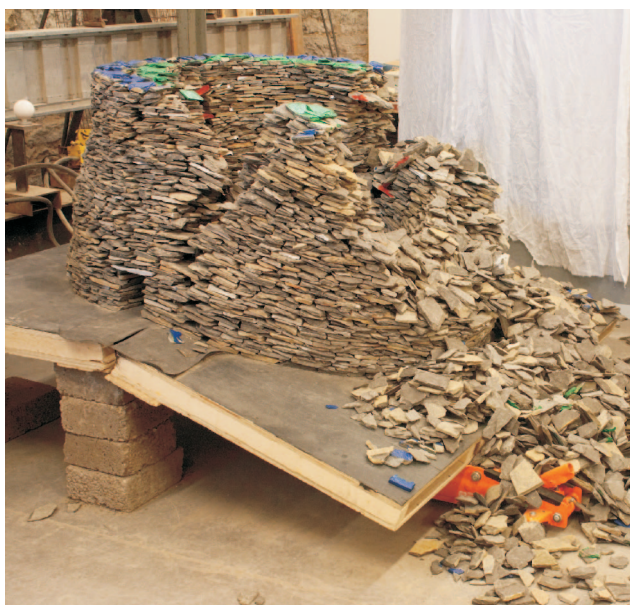
Figure 8. Collapse of ground-galleried 'Gurness' model (Southeast face)

The crack was clean in character (Figure 8), disturbing only a minimal amount of material, and as it propagated down the outer wall, on the inner face the wall voids at the north and south cardinal points expanded and the lintels spanning the internal wall voids began to fail as the distance they were spanning spread. The profile of the face under settlement rotated but, as settlement increased, no significant bulging in the profile itself was observed (Figure 10, see later).

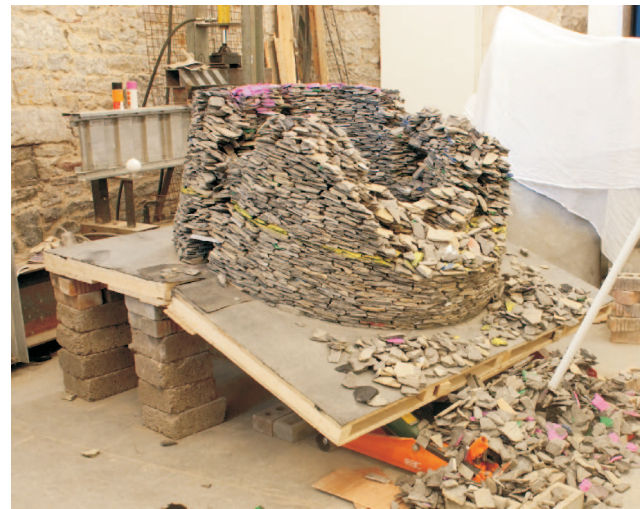
Figure 9. Collapse of solid-based 'Dun Telve' model (Southeast face)

The behaviour of the solid-based model began in much the same way as the ground-galleried model with a crack appearing at the wall head in line with the N–S hinge. The crack was more diffuse, however, and with increased settlement the crack on the South face propagated towards the entrance as opposed to straight down. The more diffused nature of the cracks meant a much greater area of masonry was destabilised above the door. A smaller volume of material was lost at the East face directly above the applied settlement (Figure 9). The full detachment of

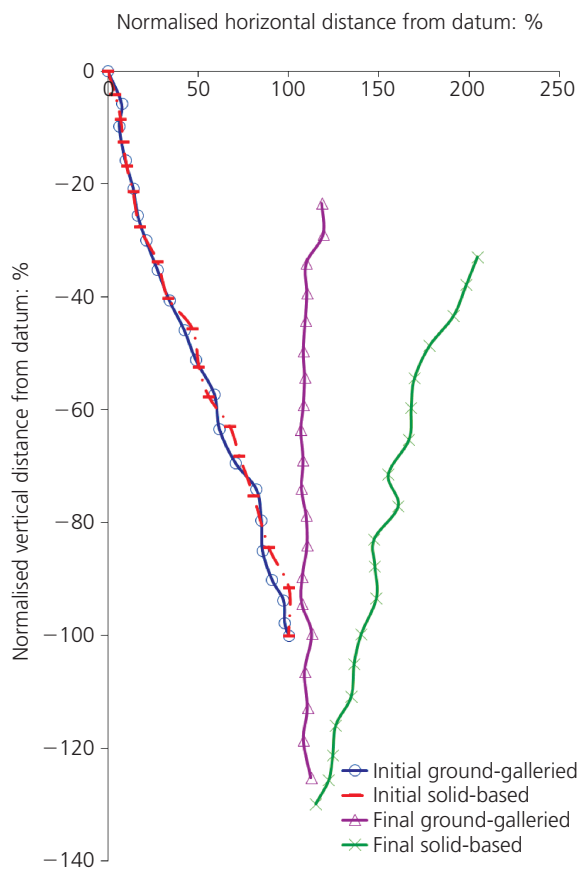
Figure 10. Normalised change between the initial and final profiles for both broch models

Owing to the difficulties inherent in the non-regular construction process, the two models were not identical and significant differences in the overall plan dimensions were recorded by the laser scans, especially in the profile at the east face where settlement was being applied. To reduce the impact of the differences in the profile and make the data more comparable, the data were normalised by dividing the values with the maximum vertical and horizontal values in the initial data set for the profiles (Figure 10). The datum was taken at the wall-head. The graph clearly shows that, once normalised, the geometries match very well, indicating the effect of the high quality of workmanship achieved.

The graph also highlights the much greater stability in rotational settlement of the solid-based structure. Comparing the values of the normalised horizontal displacement at the wall-head for the solid-based model shows an increase of close to 100% before collapse over the ground-galleried design.

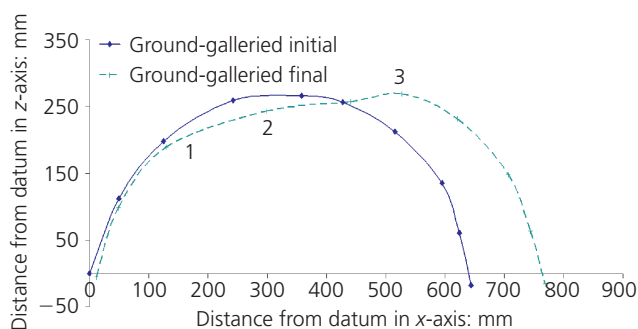
Figure 11. Change in plan at wall-head of internal wall of ground-galleried 'Gurness' model

Figures 11 and 12 illustrate the change in plan during settlement of the two models (applied at the right-hand side). The datum is

taken at the wall-head from the void at the west face clockwise to the void at the east face. They indicate the plan of the half of the internal wall opposite the entrance passage before testing and the plan at which detachment of the halves occurred.

There are clear similarities in the trends between Figures 11 and 12: at failure they achieve similar maximum distance from the datum in the x -axis, of just over 750 mm, with the solid-based

There are, however, some significant differences in the change in plan between the two models. The curvature at failure in Figure 11 between points 1 and 2 is far smoother than that in Figure 12 (Dun Telve), which has a clear change in curvature at point 1, making the behaviour of the ground-galleried broch (Gurness) more uniform up to this stage, and again indicating the more localised nature of the crack propagation. The large flat area of the solid-based plan, on the other hand, indicates how the failure had an impact across a much larger area of the wall.

Figure 12 clearly shows that the solid-based model flattens, while the ground-galleried broch (Figure 11) bulges at point 3. This suggests that there is a rotational component in the ground-galleried mode of failure, where the inner leaf of stonework is twisting round due to uneven settlement that is not present to the same extent in the solid-based model, pointing to the conclusion that, once detachment of the two halves had occurred, the ground-galleried model is more unstable.

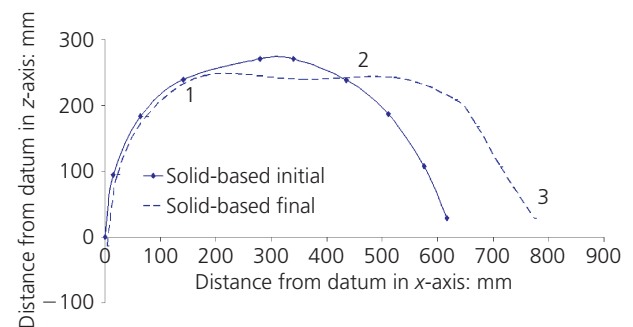
Figure 12. Change in plan at wall-head of internal wall of solid-based 'Dun Telve' model

model having a slightly larger displacement due to the greater amount of settlement it undertook before failure. A squeeze of the plan is clear in the final state, from point 2 in the ground-galleried (Figure 11) and from point 1 onwards in the solid-based (Figure 12), where the elongation of the plan caused the external walls to lean inwards. Eventually, the deformation produced slippage between the stones and, ultimately, a failure plane that propagated from the wall-head down.

Finally, the extreme displacement of the final plan (Figure 12) at point 3 shows another clear change in curvature caused by a greater relative displacement of the wall at this point. This suggests that the internal wall was sliding into the gallery at this point and could be part of what triggered the final collapse.
